November 15, 2024 2024105A

RE: Draft Pavement Investigation Data Letter Report Property Redevelopment Coleman A. Young International Airport Detroit, Michigan

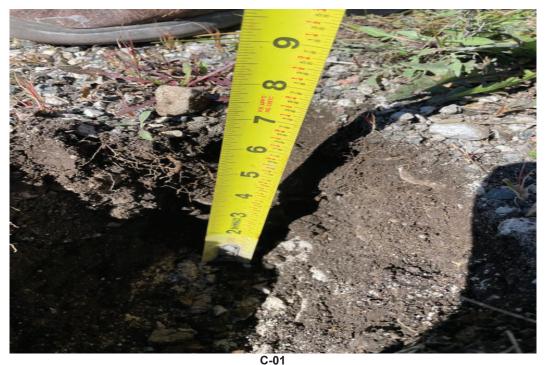
* At C-01 location, the upper 6 inches were found to consist of mixed fill material consisting of gravel, asphalt millings and soil with grass growing at the surface. Below the fill, Portland cement concrete was encountered but was completely deteriorated and not able to be cored. A hammer drill was used to determine the thickness of pavement, which was estimated to be about 6 to 8 inches. Based on satellite images, it appears this location is in a previously decommissioned taxiway.

C-01 6 inches of mixed fill (asphalt millings, gravel, soil) over 6 to 8 inches of Portland cement concrete

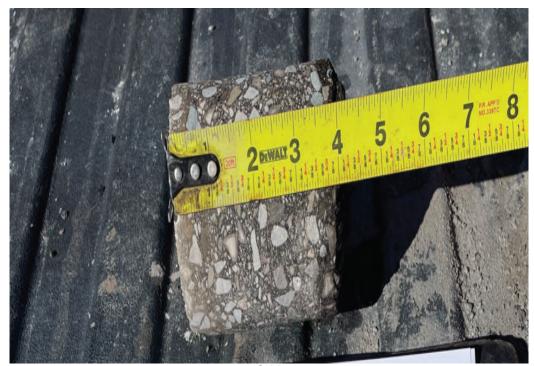
C-02 4 inches of Asphaltic Cement Concrete

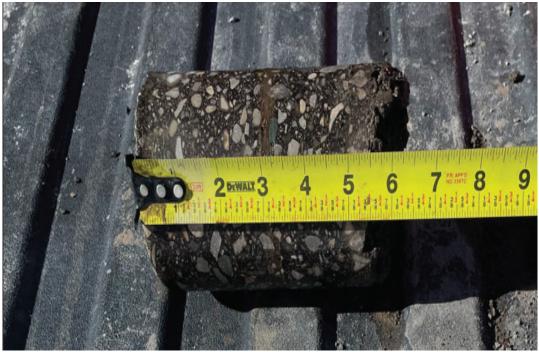
C-03 6 inches of Asphaltic Cement Concrete

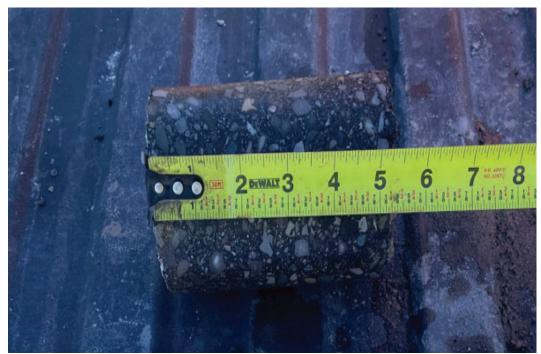
C-04 5.5 inches of Asphaltic Cement Concrete

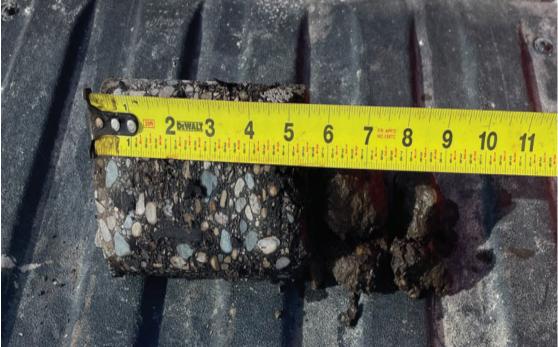
C-05 10 inches of Asphaltic Cement Concrete (lower 5 inches deteriorated)

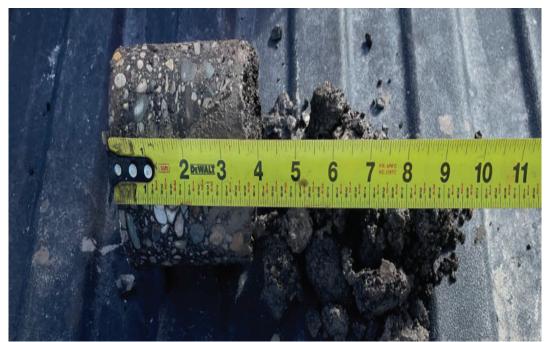
C-06 9.5 inches of Asphaltic Cement Concrete (lower 6 inches deteriorated)

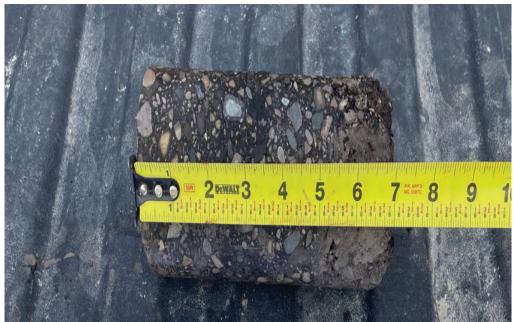
C-07 7 inches of Asphaltic Cement Concrete

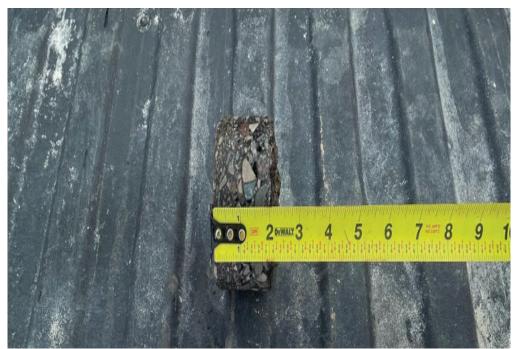
C-08 2 inches of Asphaltic Cement Concrete

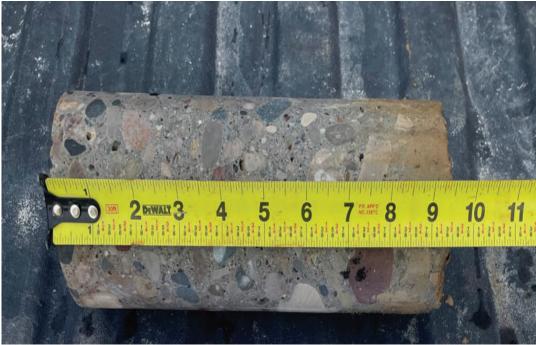
C-09 9.5 inches of Portland Cement Concrete

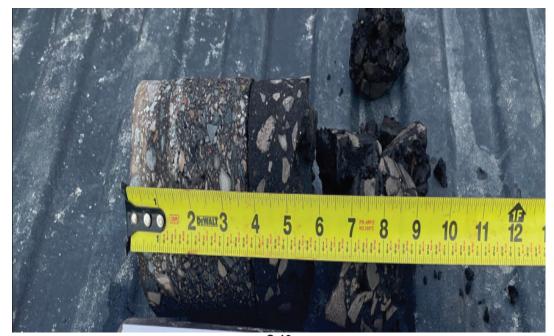
C-10 7.5 inches of Asphaltic Cement Concrete (Lower 2 inches deteriorated. Upper 3.75 inches appear to be different mix)

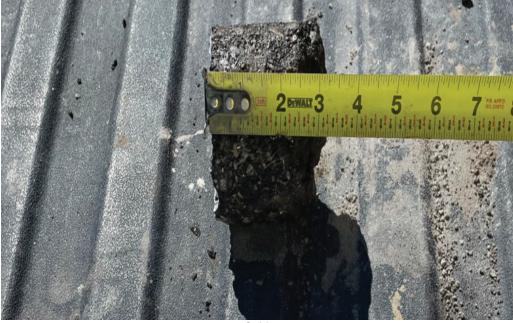
C-11	Perimeter Road	332063.41	13487806.22	626.72	3 inches of ACC
C-12	Deteriorated pavement adjacent to taxiway	332634.65	13489703.59	624.19	3.25 inches of ACC over 6.5 inches of PCC- Total 9.75 inches

C-11 3 inches of Asphaltic Cement Concrete

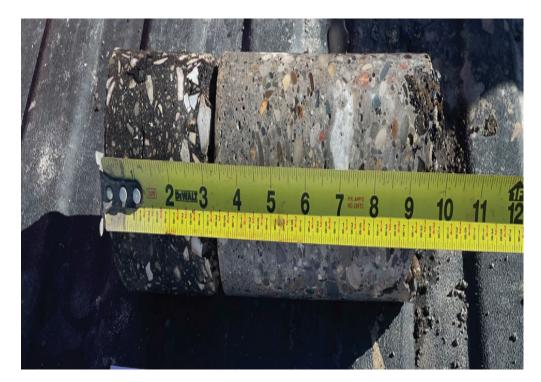
C-12 3.25 inches of Asphaltic Cement Concrete over 6.5 inches of Portland Cement Concrete
